LOCUST CREEK DAM  
SCHUYLKILL COUNTY, PENNSYLVANIA  
NATIONAL I.D. NO. PA 00699

⑥ PHASE I INSPECTION REPORT  
NATIONAL DAM INSPECTION PROGRAM

PHASE I INSPECTION REPORT  
NATIONAL DAM INSPECTION PROGRAM  
LOCUST CREEK DAM  
(TUSCARORA STATE PARK DAM)  
NATIONAL ID NO. PA 00699  
DER NO. 54-170

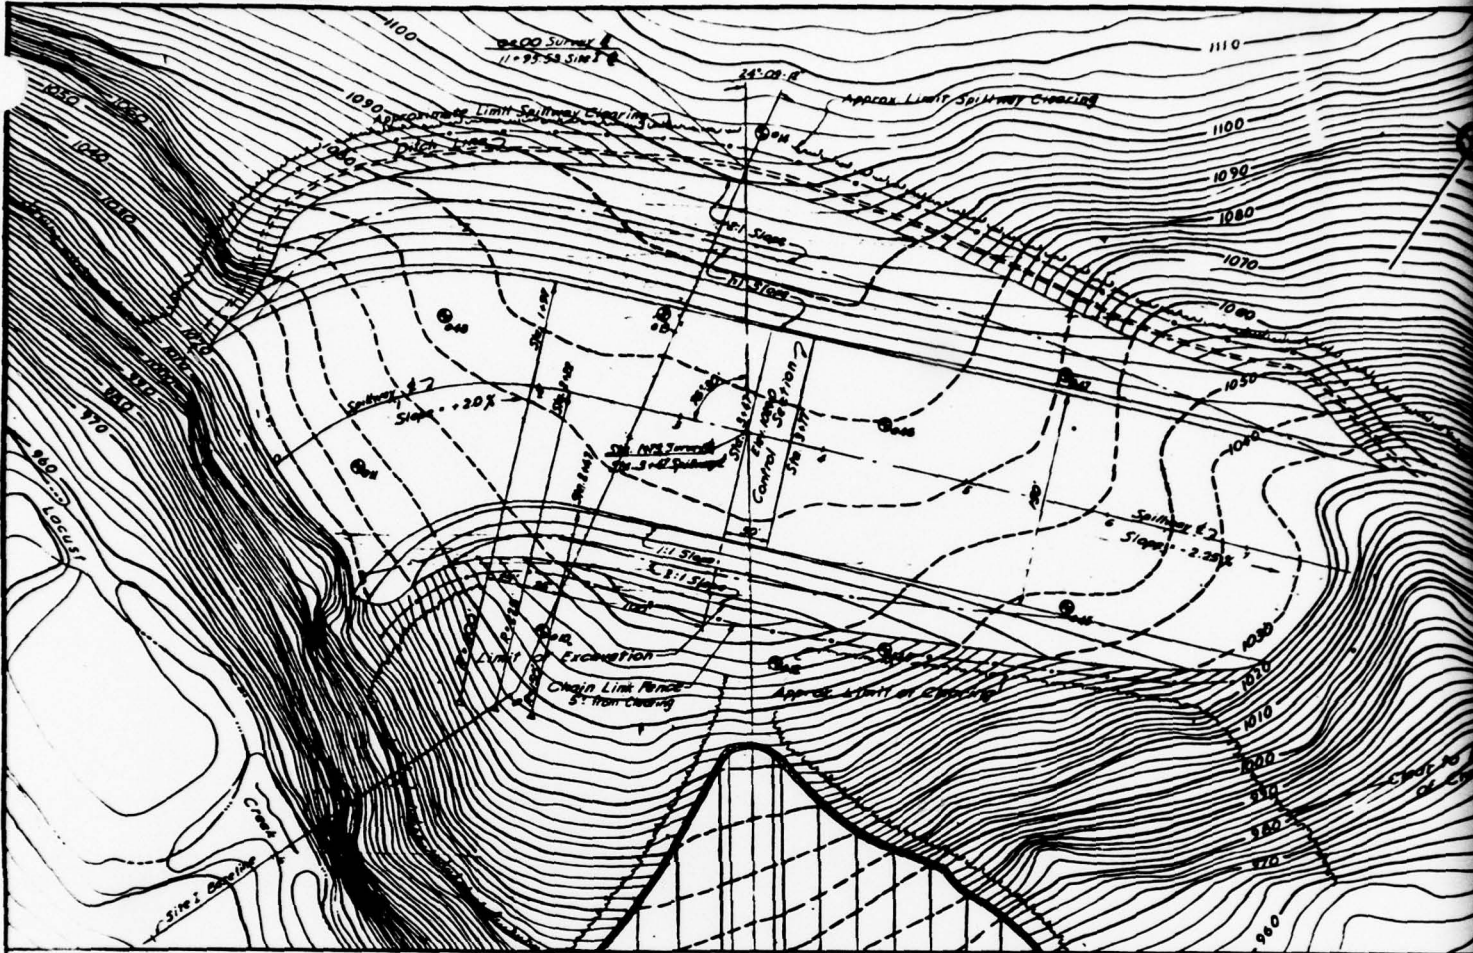
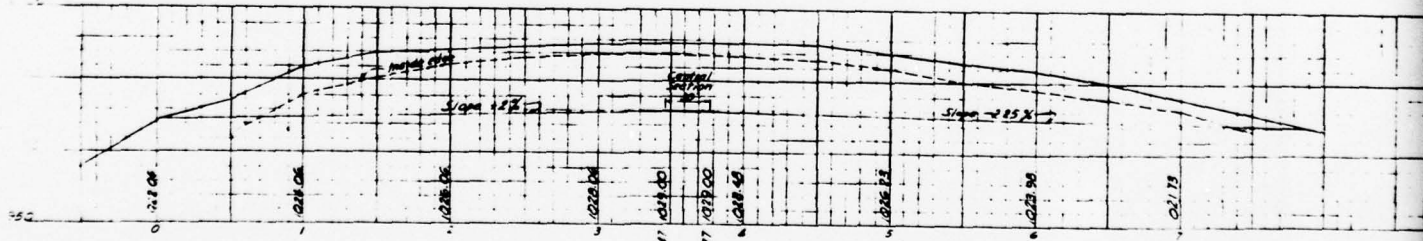
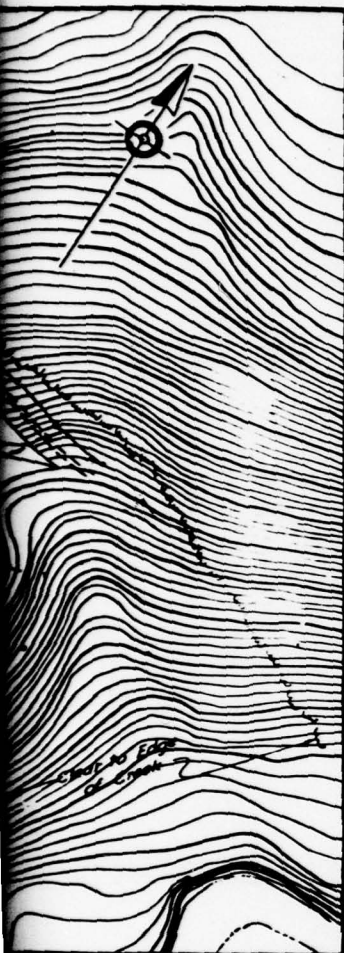
PLATE 8

The emergency spillway located left of the embankment was inspected and observed to be in good condition. Scars from previous slides principally along the left wall of the channel were observed. Some minor accumulations of rock talus were observed along the base of both sides of the channel. Surface degradation of the rock is also evident. Some vegetation is beginning to grow in the crevices and will further degrade these materials. It is not expected that this degradation will significantly affect the performance of the spillway within the near future. However, additional slope sloughing should be expected during the life of this structure. The drop-off at the end of the emergency spillway was inspected and some recent cutting of trees was observed. The channel bottom is fairly stable and in good condition.

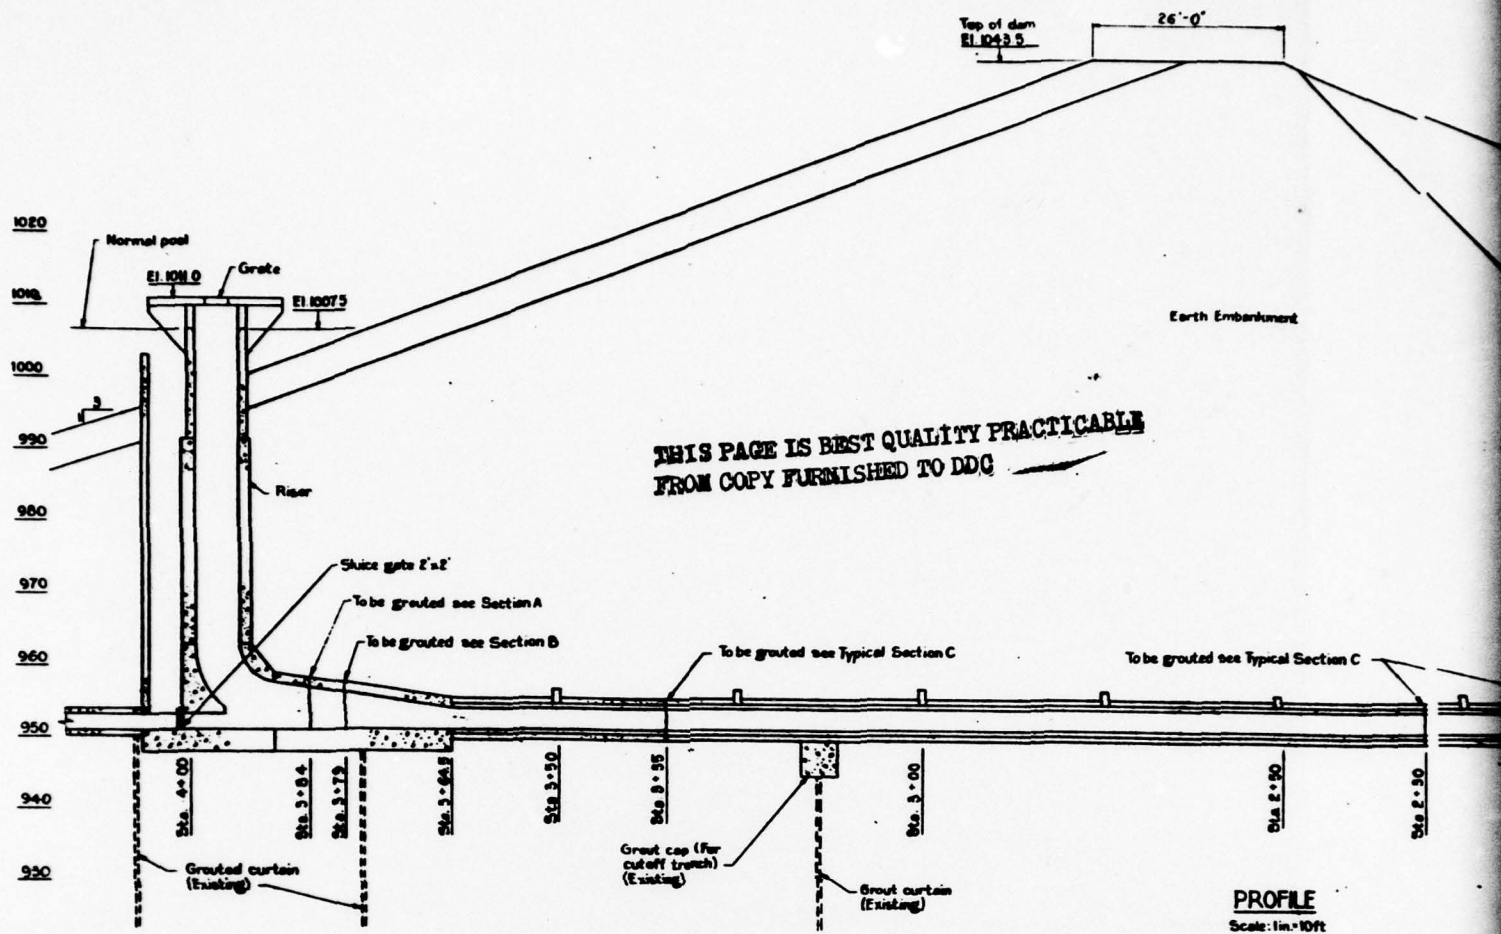
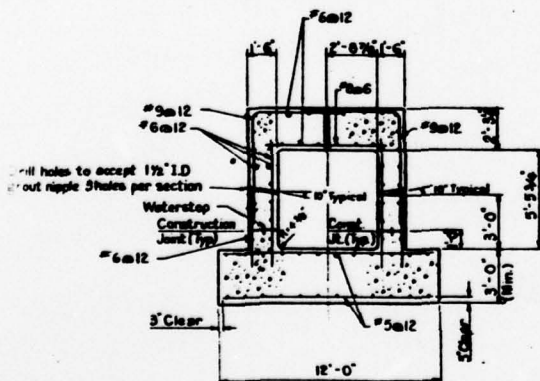
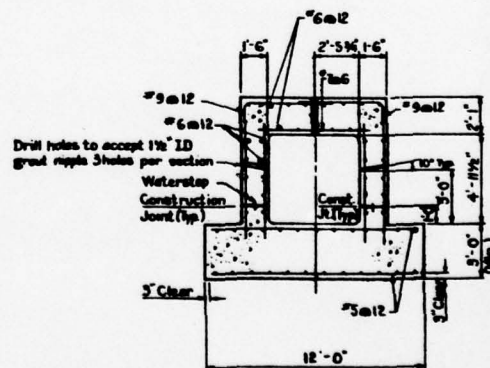
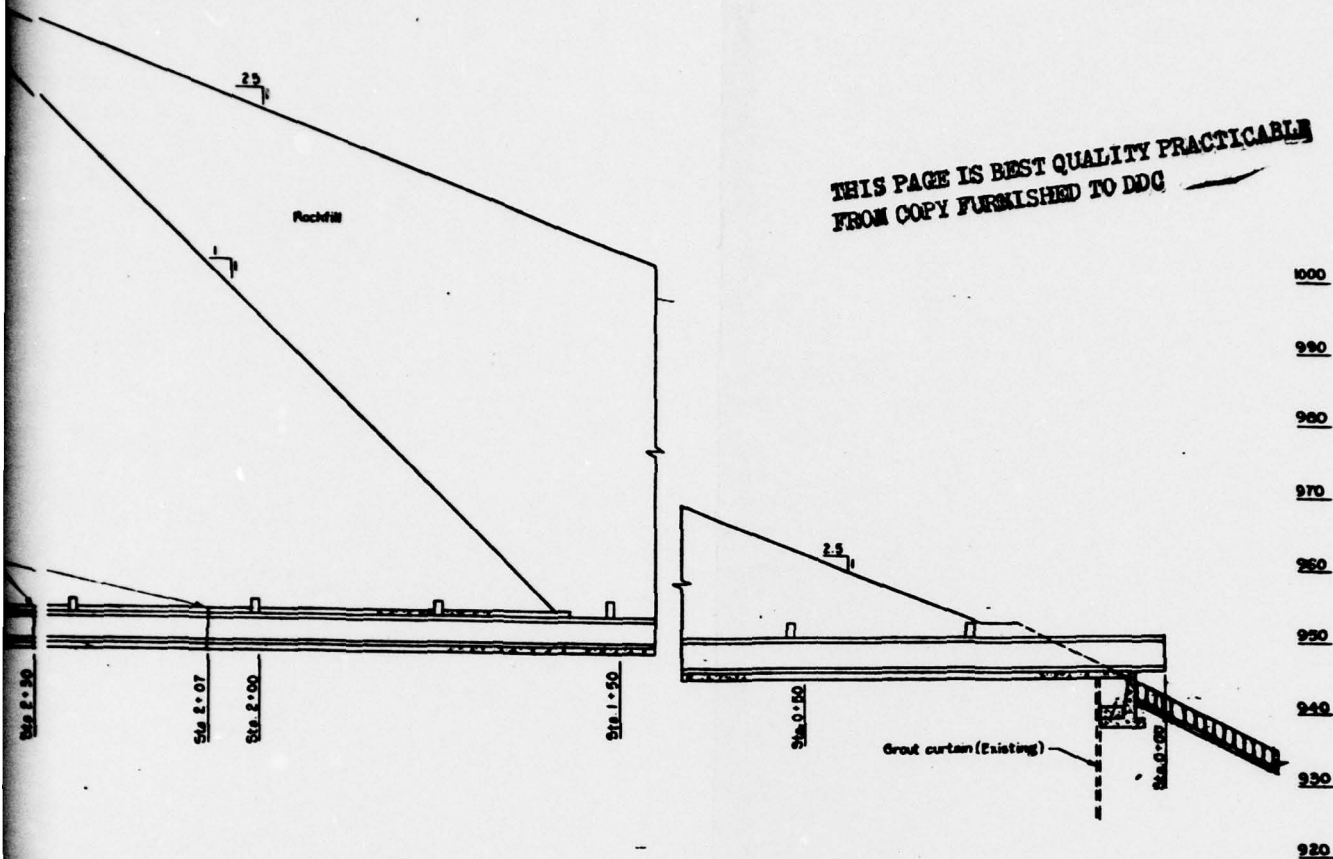
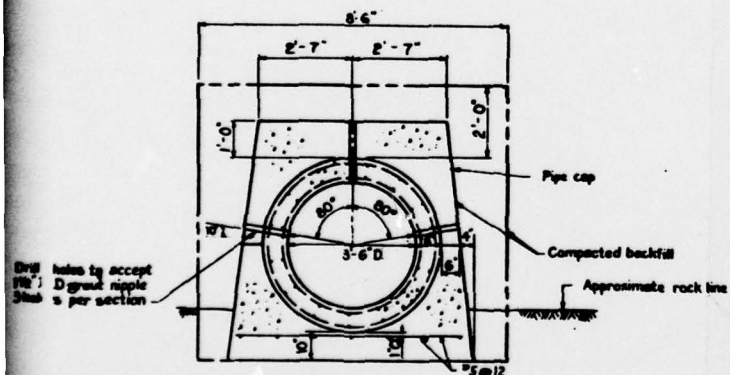
PLATE 9

Inspection of the dam following Tropical Storm Agnes, June 1972, revealed cracks in the 42-inch principal spillway conduit. In the summer of 1973, the Corps of Engineers prepared specifications to grout the conduit cracks. This work was performed by the Royal International, Inc. of Bridgeport, Pennsylvania. Details of the grouting program are presented on Plate 9 of Appendix E.

ITEM	REMARKS
MONITORING SYSTEMS	None.
MODIFICATIONS	<p>The Department of Environmental Resources issued Drawing No. R54:3-2.1, entitled "Grouting Outlet Conduit", dated 12/21/73, presented as Plate 9 of Appendix E. Repair work was performed to the conduit.</p>
HIGH POOL RECORDS	None.
POST CONSTRUCTION ENGINEERING STUDIES AND REPORTS	<p>None. The only work performed was the rehabilitation of the outlet conduit under the direction of the Corps of Engineers.</p>
PRIOR ACCIDENTS OR FAILURE OF DAM DESCRIPTION REPORTS	None.
MAINTENANCE OPERATION RECORDS	<p>None, but, the park personnel and DER inspect the dam twice a year and yearly, respectively.</p>
